**DEPARTMENT OF TRANSPORTATION**

Quality Assurance and Source Inspection

Contract #: 04-0120F4Cty: SF/ALA Rte: 80 PM: 13.2/13.9File #: 1.28**WELDING INSPECTION REPORT****Resident Engineer:**Siegenthaler, Peter**Address:** 333 Burma Road**City:** Oakland, CA 94607**Report No:** WIR-025892**Date Inspected:** 05-Aug-2011**Project Name:** SAS Superstructure**OSM Arrival Time:** 700**Prime Contractor:** American Bridge/Fluor Enterprises, a JV**OSM Departure Time:** 1530**Contractor:** American Bridge/Fluor Enterprises, a JV**Location:** Job Site**CWI Name:** Fred Vonhoff**CWI Present:** Yes No**Inspected CWI report:** Yes No N/A**Rod Oven in Use:** Yes No N/A**Electrode to specification:** Yes No N/A**Weld Procedures Followed:** Yes No N/A**Qualified Welders:** Yes No N/A**Verified Joint Fit-up:** Yes No N/A**Approved Drawings:** Yes No N/A**Approved WPS:** Yes No N/A**Delayed / Cancelled:** Yes No N/A**Bridge No:** 34-0006**Component:** OBG Component**Summary of Items Observed:**

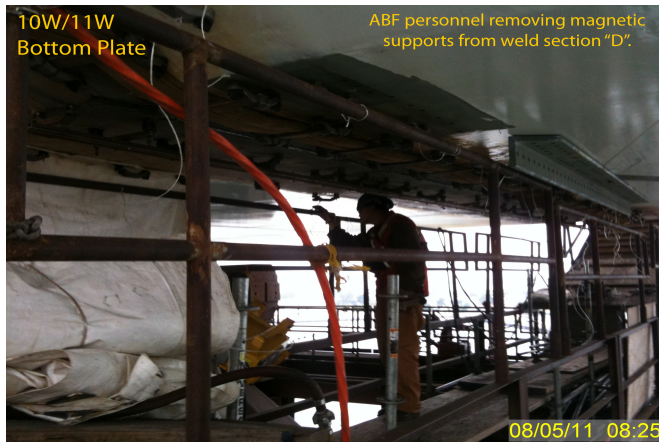
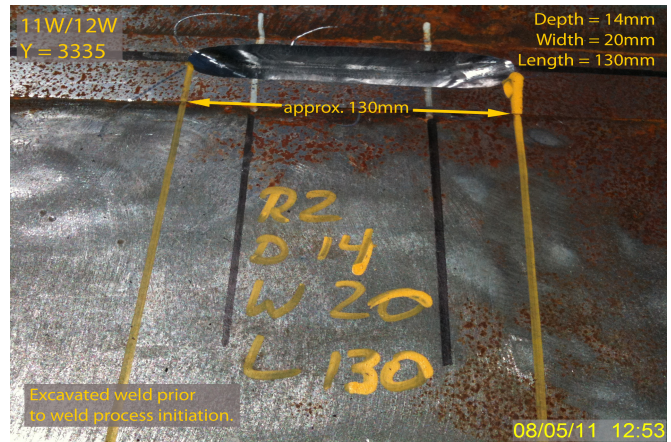
This QA randomly observed ABF/JV qualified welder Wai Kit Li #2953 performing Shielded Metal Arc Welding (SMAW) with 1/8" diameter E7018H4R electrode and implementing Caltrans approved Welding Procedure Specification (WPS) ABF-WPS-D15-1001-R.

The joint being welded, designated as A1, was a second time repair (R2) that was previously rejected by Quality Control (QC) inspection using the Ultrasonic Testing (UT) inspection method.

This QA randomly observed the excavation of this rejectable indication (appearance of slag inclusions). This weld was excavated to a depth = 14mm, a width = 20mm, and a length = 130mm, from Y location 3335mm – 3465mm, as recorded by Mr. Vonhoff.

Approximately 12:45 this QA randomly observed QC Inspector William Sherwood perform Magnetic Particle (MT) inspection to confirm the excavation and removal of the rejectable indication prior to Mr Li starting the repair welding process.
